[Docket No. FAA-2012-0409; Directorate Identifier 2011-SW-055-AD;

Amendment 39-17020; AD 2011-18-52]

Airworthiness Directives; Agusta S.p.A. Helicopters

2011-18-52 **AGUSTA S.p.A. (AGUSTA)**: Amendment 39-17020; Docket No. FAA-2012-0409; Directorate Identifier 2011-SW-055-AD.

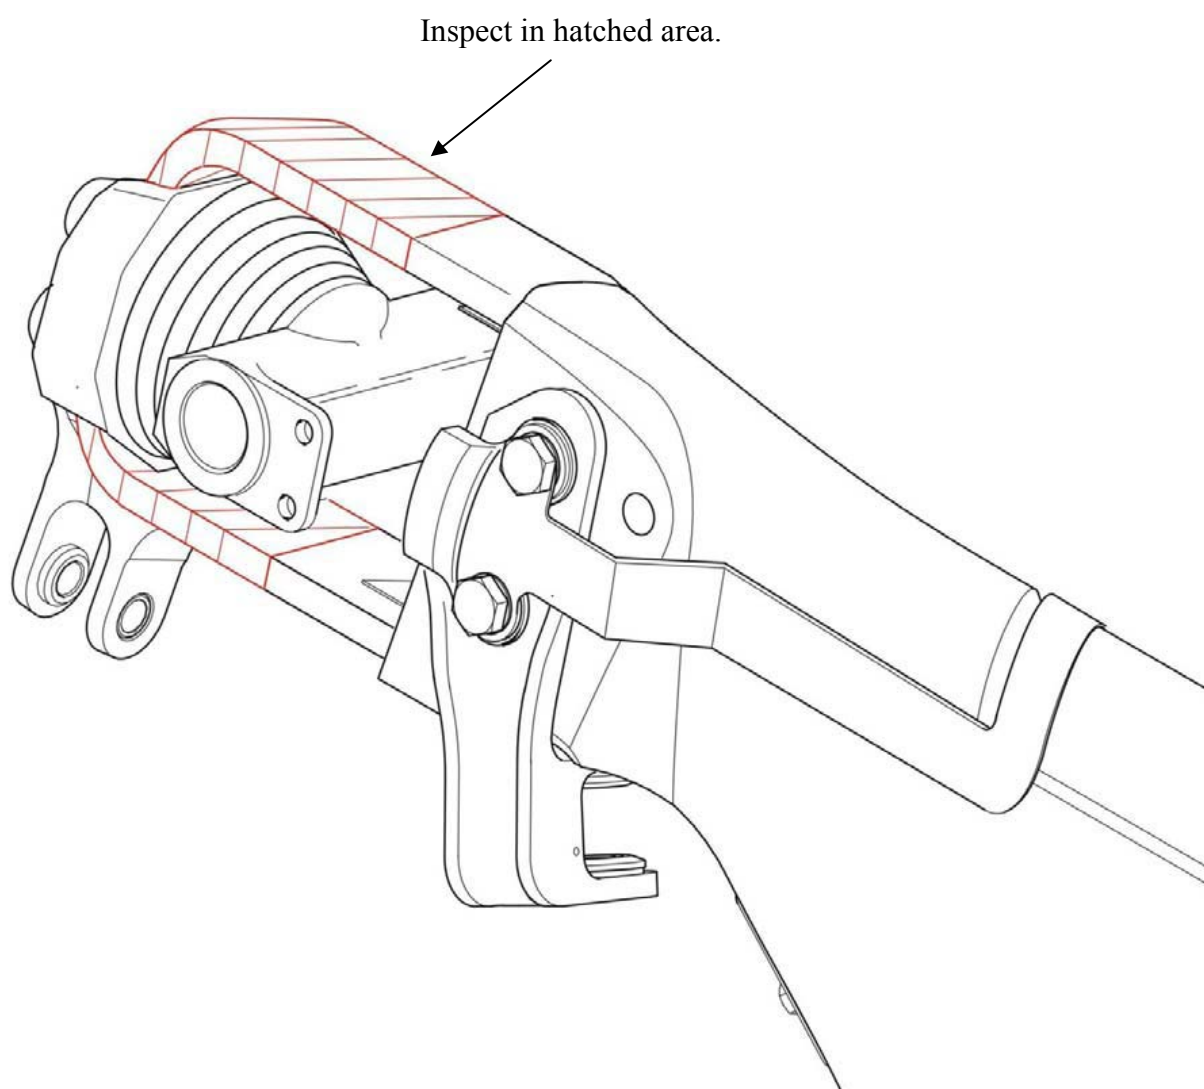
This AD defines the unsafe condition as cracks in a T/R blade. The actions in this AD are intended to detect and prevent a crack in a T/R blade which could lead to failure of a T/R blade and subsequent loss of control of the helicopter.

(3) Within 25 hours TIS, and thereafter at intervals not to exceed 25 hours TIS, visually inspect the T/R blade for a crack or damage that exceeds the limits of the applicable maintenance manual. Inspect in the area depicted in the following figure using a mirror, magnifying glass (5X or greater), and light source, or borescope.

(4) If there is a crack, or if there is damage that exceeds the limits of the applicable maintenance manual, before further flight, replace the T/R blade with an airworthy T/R blade.
